Geoinformatics Perspective of Landslide and Catastrophic Flash Floods in Dhauliganga, Uttarakhand, India

Abstract: On 07 February 2021, around 10:30 hrs local time catastrophic flash flood occurred in the Dhauliganga River (a tributary of the Ganga River) near Rini village at 2000 m above MSL (mean sea level) (Chamoli District), which killed 79 people and about 125 people were missing. Part of the area belongs to Nanda Devi Biosphere Reserve, which is completely protected from human interventions. Further, on the Dhauliganga River, two run-of-river hydroelectric power Rishiganga Small Hydro (13.2 MW) at 1975 m above MSL and Tapovan Vishnugad (520 MW) at 1795 m above MSL projects were also severely damaged due to the devastating flash flood. More than 150 workers were also trapped in the under-construction power tunnel of the Tapovan Vishnugad project. Initial assessment on the day of the event suggested that there was a glacial burst. Later, it was evaluated through time series of high spatial resolution remote sensing images of various satellites that a large part of a north-facing triangular-shaped slope at 5540 m above MSL had failed, which was also supporting a small hanging g

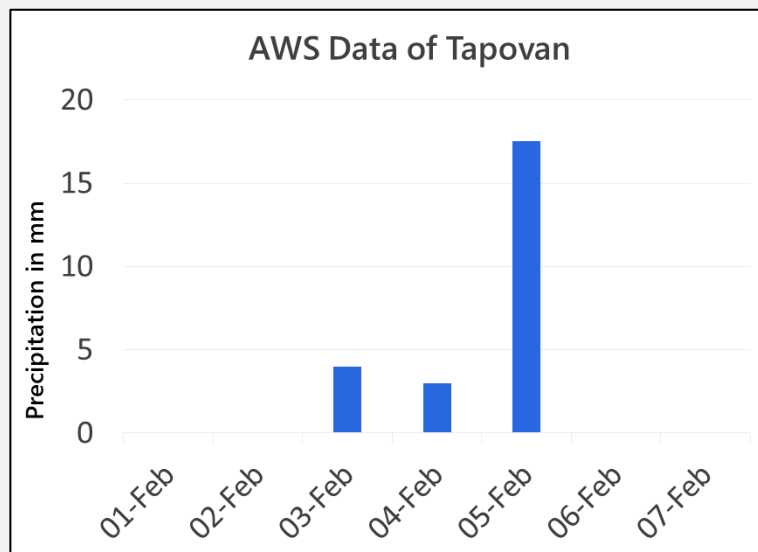
Figure 3. Total precipitation (snow and rain) occurred in the region. Data recorded at Automatic Weather Station, Tapovan)

Initially, between 03-05 February 2021, the Dhauliganga River region received heavy snowfall (Fig. 3), which overloaded high, vulnerable, very steep slopes and in the morning of 07 February 2021, a north-facing triangular-shaped slope failed, which was also supporting a small hanging glacier. This has been assessed through time series of high spatial resolution remote sensing images of various satellites. The meteorological variables, e.g., air temperature, surface temperature, turbulent heat flux, radiative fluxes, heat and momentum transfer coefficients, specific humidity and upper wind patterns, were found to show significant departures from their usual patterns starting from 72 h until a few hours before the rock-ice avalanche event mentioned by (Srivastava et al., 2022) using Weather Research and Forecasting (WRF) model. A similar pattern was observed in the parameters downloaded from <https://power.larc.nasa.gov/data-access-viewer> and then the graph was plotted (Fig. 4). The average 2 m air temperature and land surface temperature near the avalanche site during the 48 h before the event were found to be much lower than the average temperatures post-event. The solar flux mostly remained downward (negative) in the 72 h before the event and was found to have an exceptionally large negative value a few hours before the rock-ice avalanche event. The part of the Himalayan region falling in the simulation domain received a significant amount of rainfall on 4 February, around 48 h prior to the event, while the rest of the days pre- and post-event were mostly dry. The data (Fig. 3) and graph (Fig. 4) presented here suggest the identification of the possible trigger factors of the event.

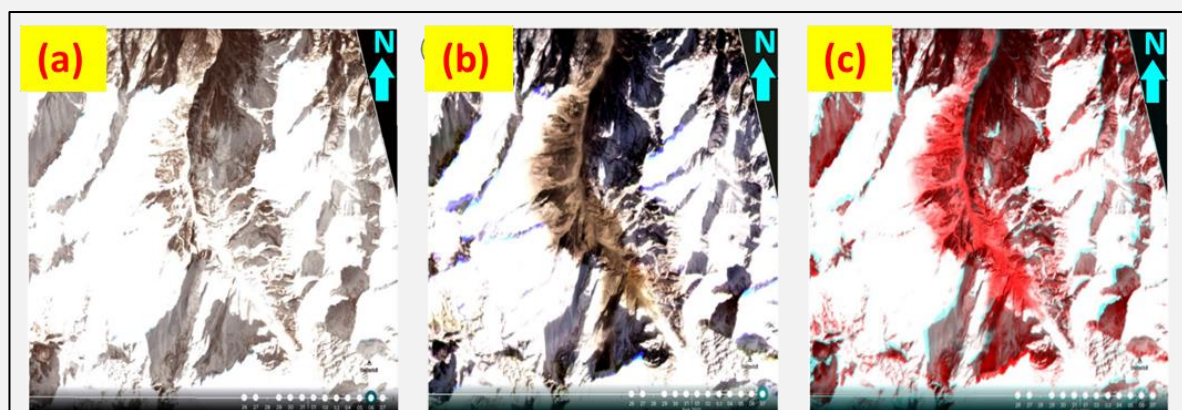
Figure 6. Pre-event Pléiades image of 06 February 2021 (a); Pléiades image of 07 February 2021, just after the rockslide event (b); Pseudo Colour Transformed (PCT) image of Band 3 (c) depicts changes (in red colour) that occurred between 06-07 February 2021 images. White areas decipher no changes. Cyan-coloured areas in PCT image (c) are due to differential shadows between images (a) and (b). Dust clouds in (c) along Raunthi Gadhera can be seen very evidently in red colour

In the present study, it has been further investigated to assess changes that occurred before and after the 07 February 2021 flash flood event by employing (i) high-resolution images of 06 February 2021 and 07 February 2021 of Pléiades satellite and (ii) a change detection pseudo colour transformation (PCT) technique developed by Saraf (1998). The conventional PCT technique facilitates the combination of various bands in different colour schemes, such as RGB, IHS and CMY. However, instead of using the different bands of the same date data, an approach developed by Saraf (1998) has been adopted in the present study to map the landslides/rockslide-induced ground changes using available high-resolution pre- and post-event datasets of Pléiades satellite. Both pre- and post-event Pléiades scenes were georeferenced using an image-to-image rectification technique. Since the available Pléiades images were in false colour composite (FCC) format and therefore first splitting of FCCs was done into their original colour components, i.e. red, green and blue (RGB), the pre-earthquake scene is kept in the red channel and the post-earthquake scene in the green and blue channels (Fig. 6). This has provided a change index with red depicting positive change in terms of reflectance between two dates, blue and green depicting negative change, and black and white depicting no change.

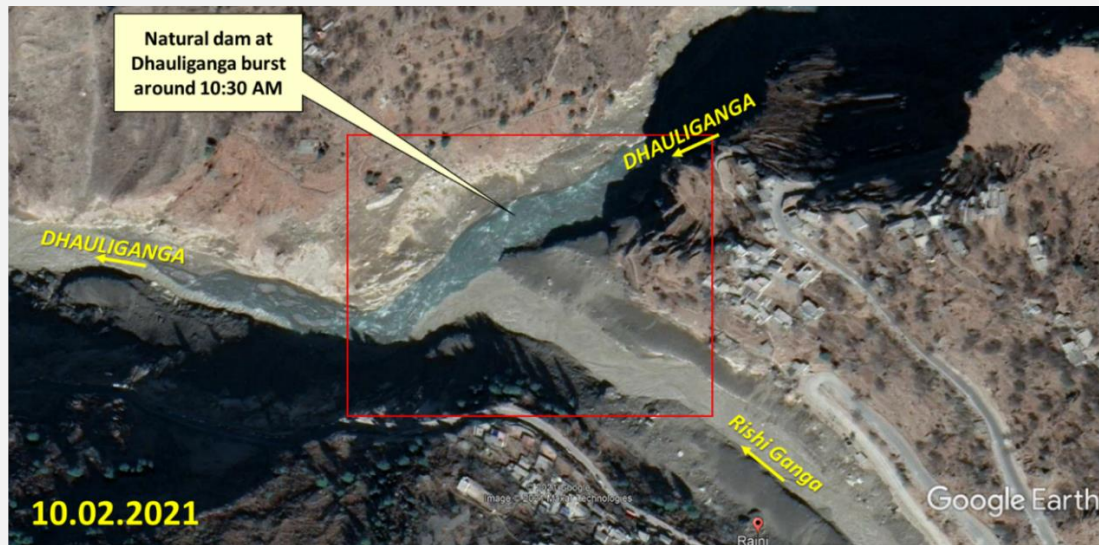
Figure 9. Google Earth image of 10 February 2021 brings a remnant of the broken natural dam, which can be realised clearly across the Dhauliganga River. As can be seen that heavy and abrupt moraine sediments (initially Rishiganga brought dark grey sediments as can be seen on both banks of Rishiganga River, and later it brought light grey sediments) were brought by the Rishiganga which initially blocked the flow of Dhauliganga. However, due to heavy flow in the Rishiganga, the temporary natural dam could not sustain and broke quickly, causing a devastating flash flood in the downstream stretch of Rishiganga

Rapid and colossal glacial debris flow into the Raunthi Gadhera initially blocked the flow of Dhauliganga near Rini village, which later failed around 10:30 hrs (local time) on 07 February 2021 and brought a calamitous flash flood in the Dhauliganga River, which killed 79 people and about 125 people are still missing. Due to the heavy flow of moraine sediments, both Rishiganga and Dhauliganga rivers were blocked. However, as clearly evident in post-event satellite images, natural damming at the Dhauliganga River near Rini village broke around 10:30 hrs (Fig. 9) on the same day and caused a devastating flash flood in the Dhauliganga River, damaging structures which came along the path of the river within a few minutes time even beyond Vishnuprayag town (Fig. 10).

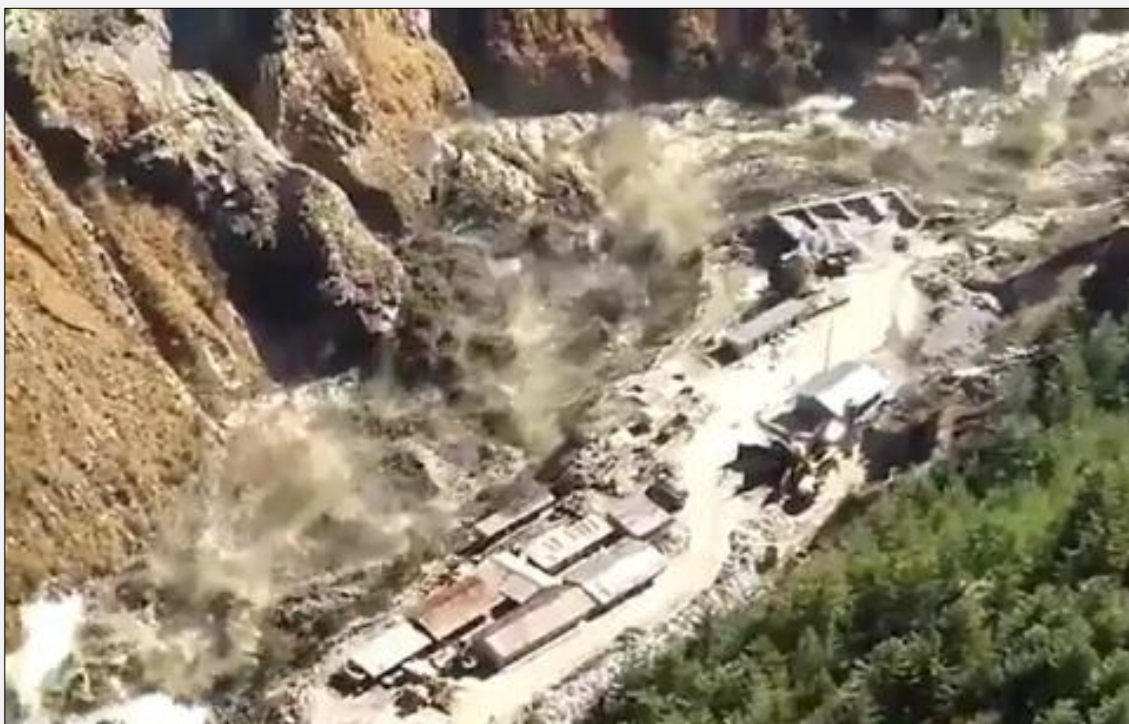
Figure 10. Image showing the debris flow along the path of Dhauliganga River, which completely destroyed the structures coming on the way

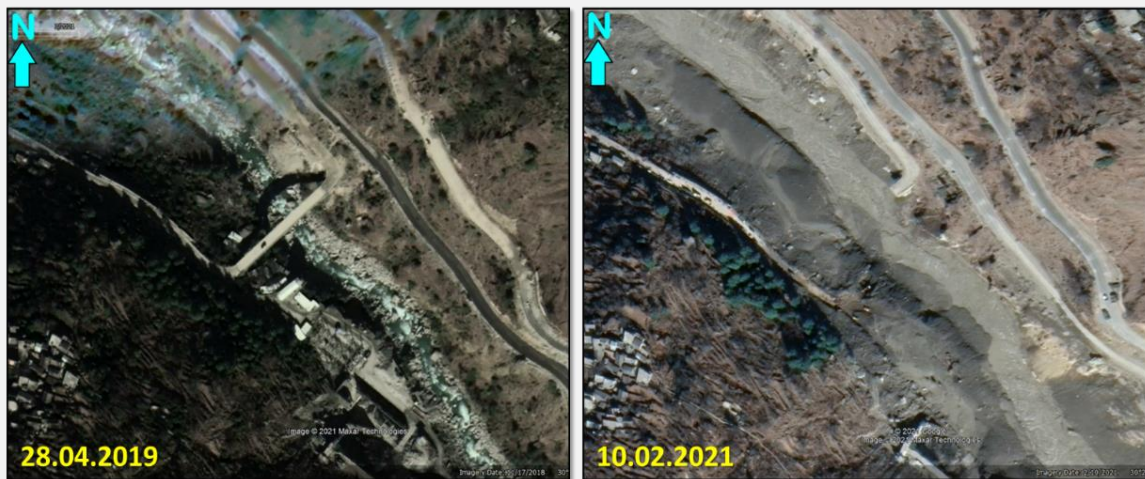
Figure 13. Pre- and post-event Google Earth images of the Rishiganga Hydro Power Project (13.2 MW) clearly show a complete washout of the operational hydropower project due to the devastating flash flood of 07 February 2021

The two run-of-river hydroelectric power Rishiganga Small Hydro (13.2 MW) at 1975 m above MSL and Tapovan Vishnugad (520 MW) at 1795 m above MSL projects which were also severely damaged due to the devastating flash flood (Figs. 13, 14 and 15). More than 150 workers were trapped in the under-construction power tunnel (Fig. 14) of the Tapovan Vishnugad project. A visual comparison of images and field photographs is shown in Figs. 14 and 15 emphatically bring the extensive damages caused by the flash flood, which were caused in a few minutes. The damage to all kinds of structures along the Rishiganga-Dhauliganga Rivers runs beyond these project sites. In fact, any structure along these rivers was completely destroyed within a few minutes time even beyond Vishnuprayag town.

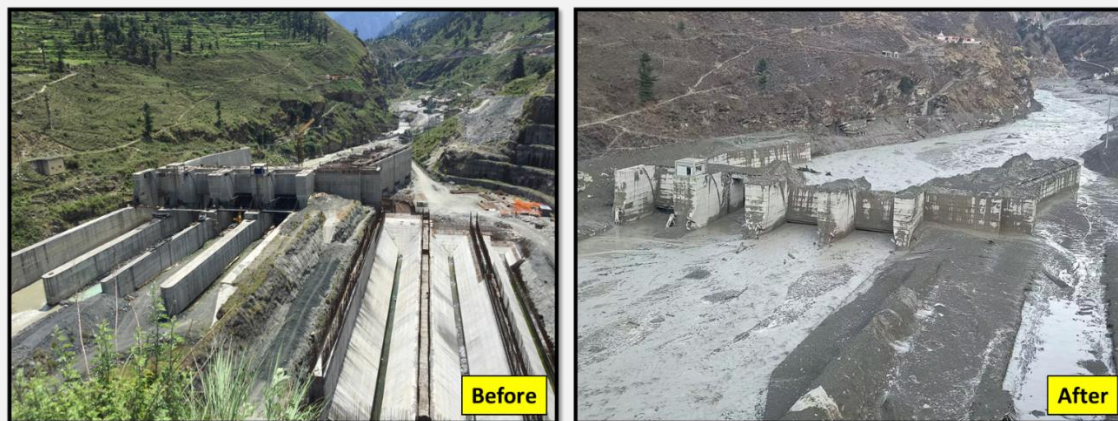
Figure 15. Before and after flash flood conditions of Tapovan Vishnugad Hydro Power Project (520 MW) clearly show severe damage to the under-construction hydropower project due to the devastating flash flood of 07 February 2021 (*Source:* Before - http://webtag.ae/rithwik/view/front/modules/_portfolio/data/27/hURCWLUssu3q.JPG After - <https://static.toiimg.com/thumb/msid-80738861,width-1200,height-900,resizemode-4/.jpg>)
